-FINAL-
Lake Greenwood Diagnostic Study

July 2001

Lake Greenwood Diagnostic Study Executive Summary

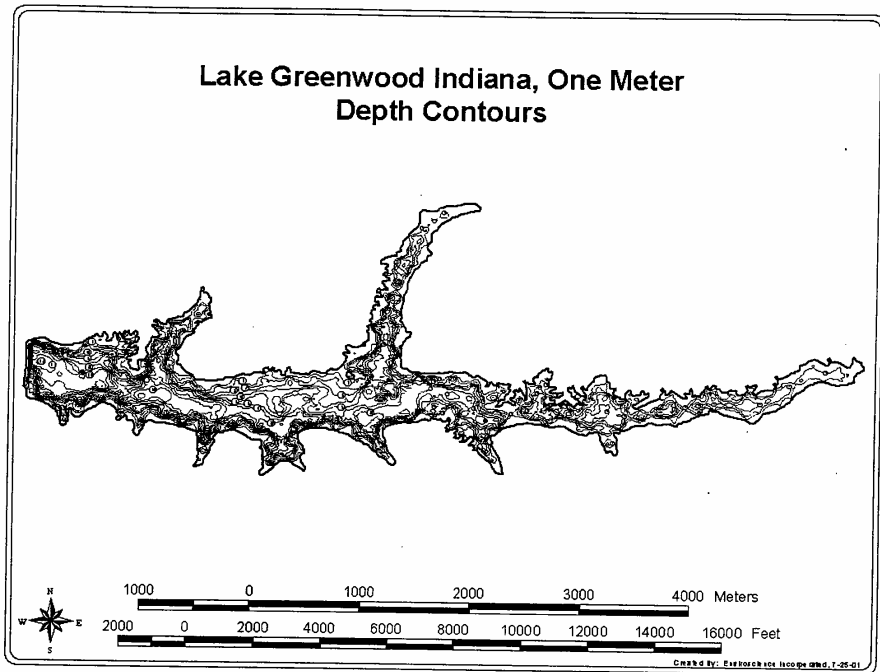
Figure 2. Bathymetric map of Lake Greenwood. Prepared by: EnviroScience, Inc., July 2001.

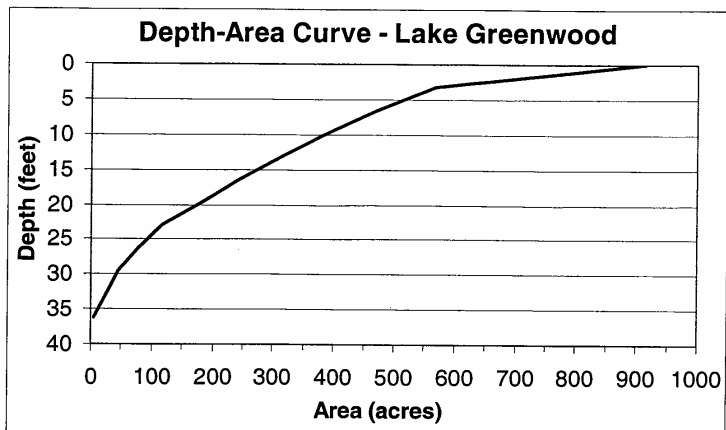
Figure 3. Depth-area curve for Lake Greenwood. Prepared By: EnviroScience, Inc., July 2001.

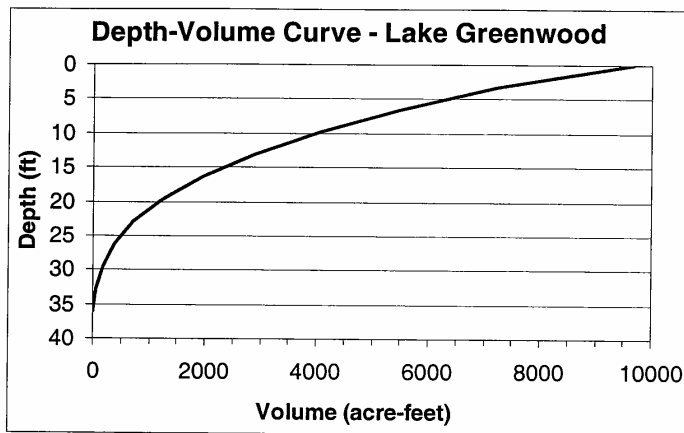
Figure 4. Depth-volume curves for Lake Greenwood. Prepared By: EnviroScience, Inc., July 2001.

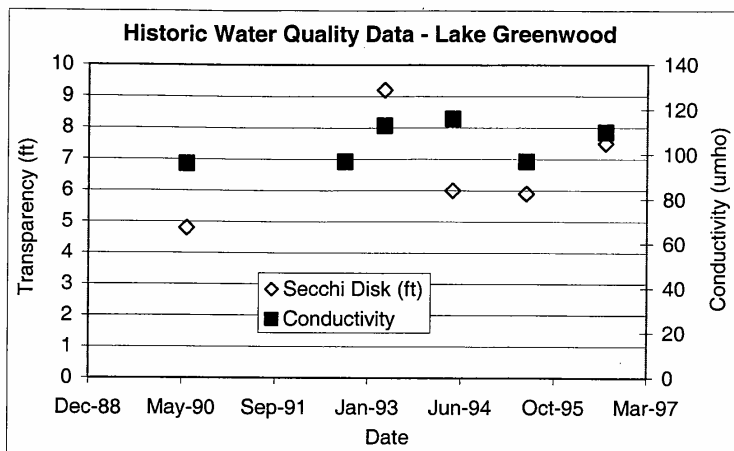
The only parameters for which there is more than one measurement are Secchi disk transparency and conductivity. There is no apparent trend for these parameters over the six years of data.

Figure 9. Historic water quality data for Lake Greenwood.
Sources: Surprenant (1996); CLP (1996)

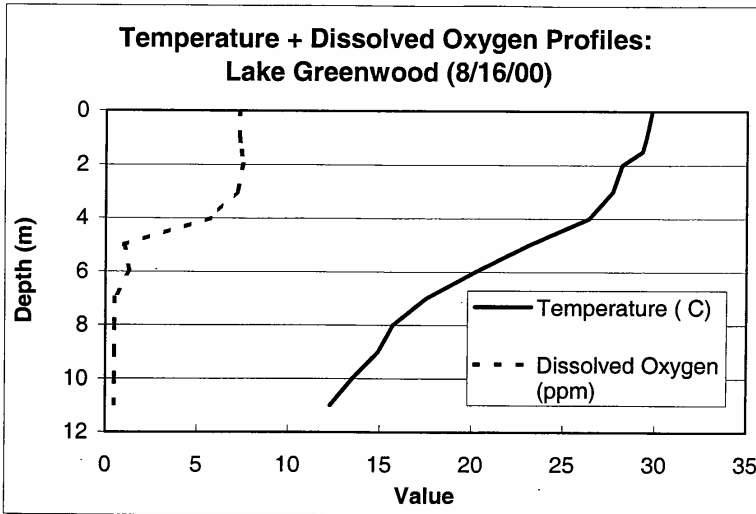
Lake Greenwood's epilimnion is saturated with dissolved oxygen. Photosynthesis by phytoplankton and contact with the atmosphere work to keep epilimnetic oxygen concentrations in equilibrium with those in the atmosphere. Below the mixing zone, respiration exceeds photosynthesis and thus, oxygen concentrations decline abruptly. Below seven meters, all oxygen within Lake Greenwood was consumed producing an anoxic environment.

Figure 15. Temperature and dissolved oxygen profiles for Lake Greenwood.

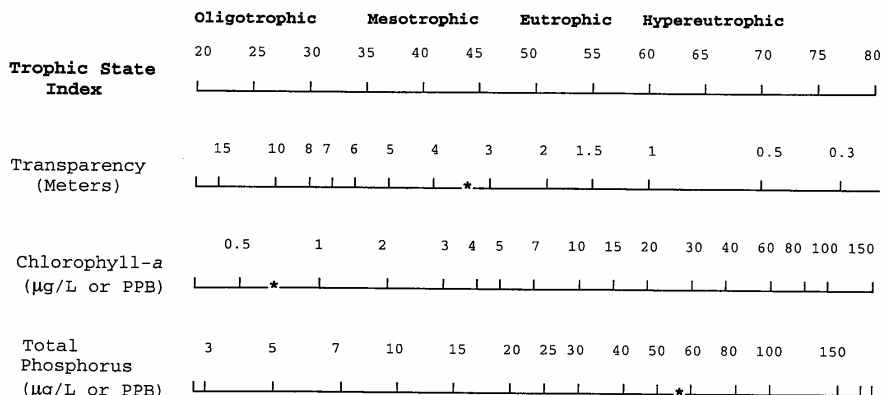
CARLSON'S TROPHIC STATE INDEX

The Carlson TSI. The most widely used and accepted TSI is one developed by Bob Carlson called the Carlson TSI. Carlson analyzed summertime total phosphorus, chlorophyll *a*, and Secchi disk transparency data for numerous lakes and found statistically significant relationships among the three parameters. He developed mathematical equations for these relationships and these for the basis for the Carlson TSI. Using this index, a TSI value can be generated by one of three measurements: Secchi disk transparency, chlorophyll *a* or total phosphorus. Data for one parameter can also be used to predict a value for another. The TSI values range from 0 to 100. Each major TSI division (10, 20, 30, etc.) represents a doubling in algal biomass (Figure 16).

Figure 16. Carlson's Trophic State Index with Lake Greenwood values indicated by (*). This is similar to the results comparing our data with Vollenweider's data and is, we believe, a better measure of the true trophic status of Lake Greenwood.

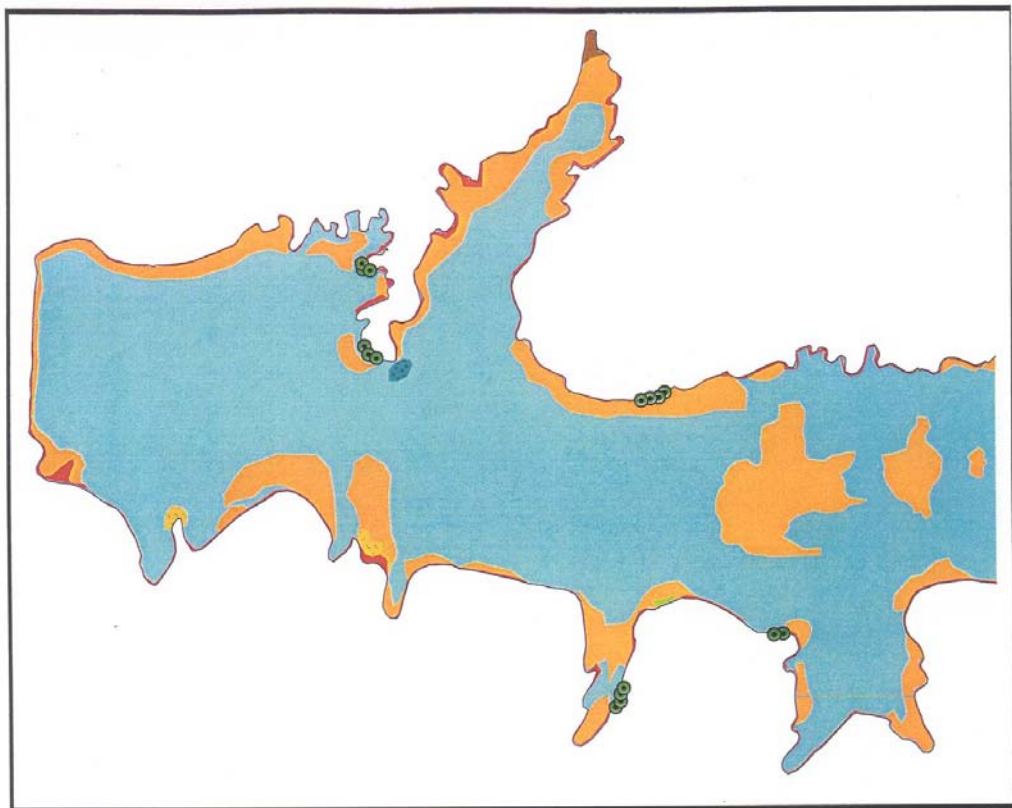
For the most part, the shoreline of Lake Greenwood is stable. Areas of shoreline erosion are indicated in Figures 18-20. Our best estimate is that there is less than 600 feet of eroded shoreline needing stabilization. Most individual areas observed were relatively short sections (30 feet) and 3 to 6 feet high. However, several areas on the south side of the lake west of the marina (Figure 19-20) have eroded banks exceeding 10 feet in height.

Figure 18. Lake Greenwood Littoral Vegetation & Shoreline Erosion #1

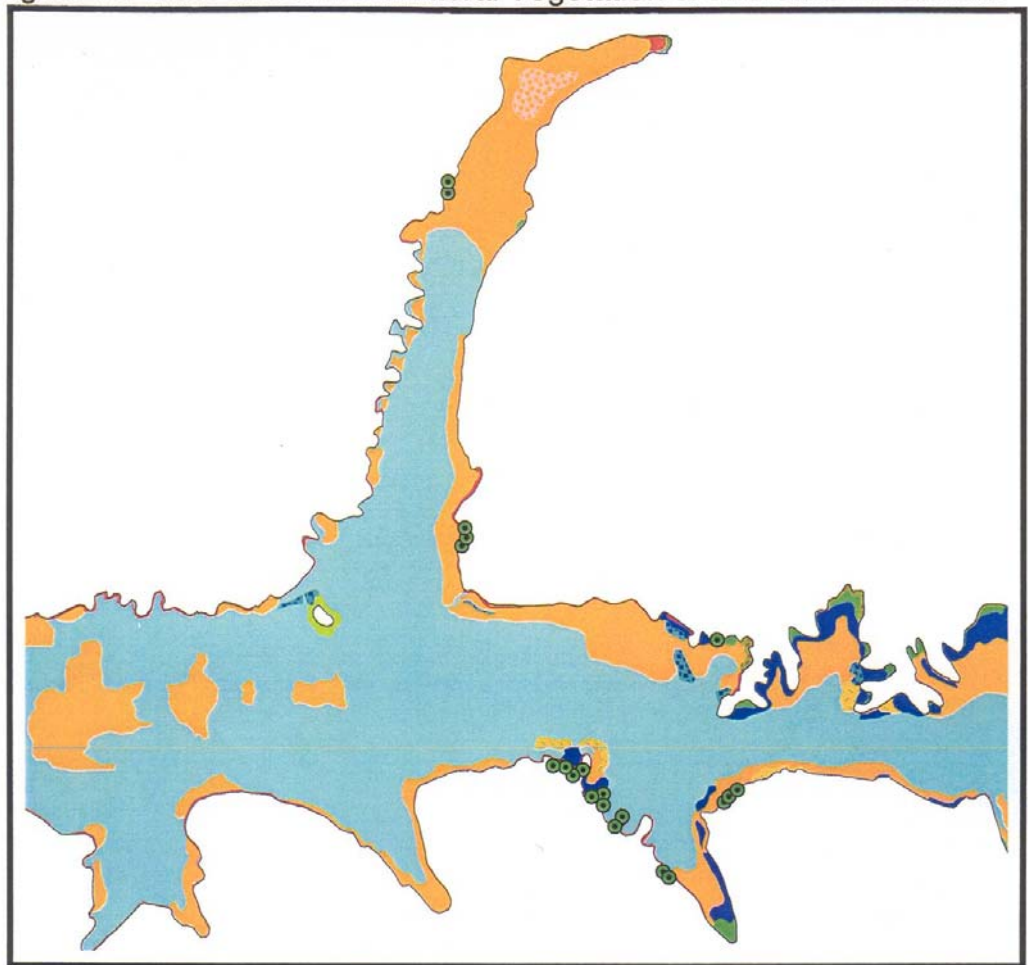
Figure 19. Lake Greenwood Littoral Vegetation & Shoreline Erosion #2

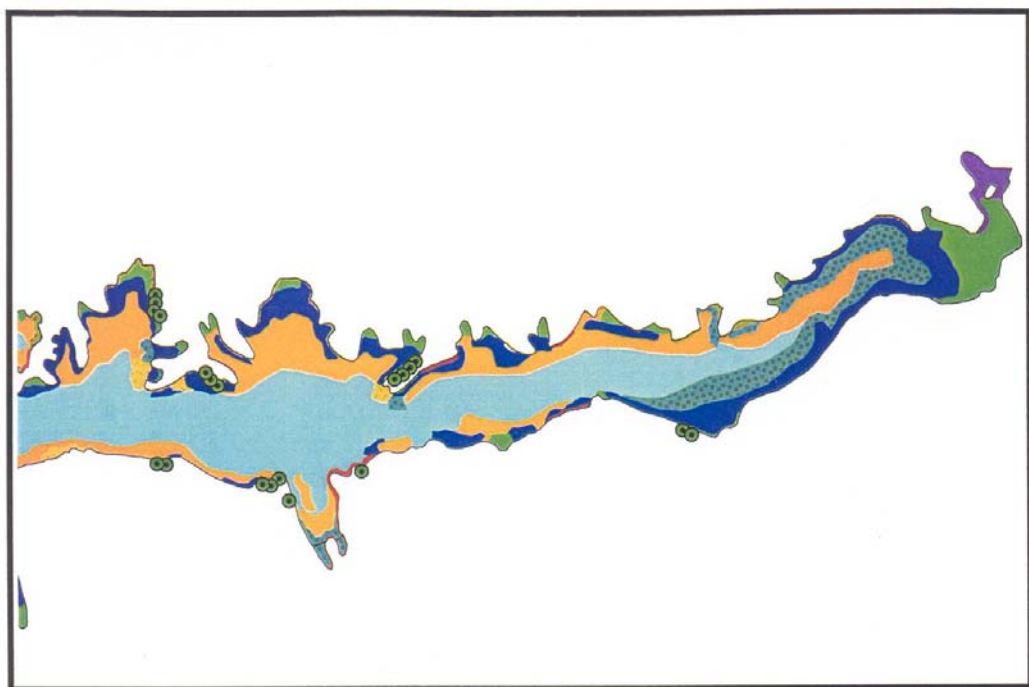
Figure 20. Lake Greenwood Littoral Vegetation & Shoreline Erosion #3

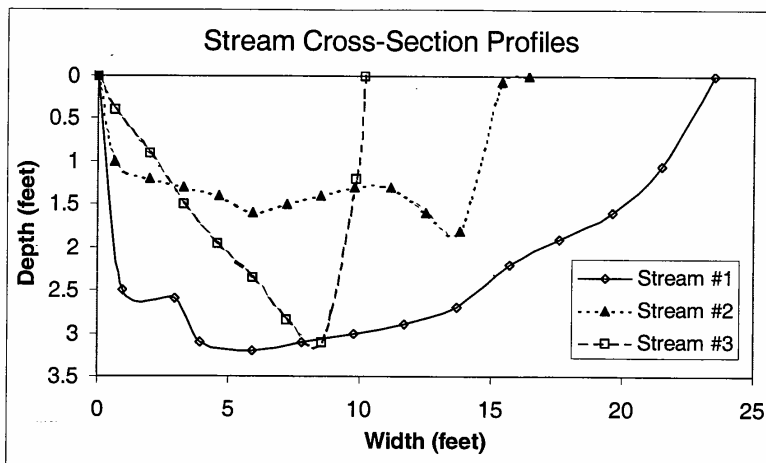
Figure 21. Cross-section profiles of the streams sampled at storm flow.

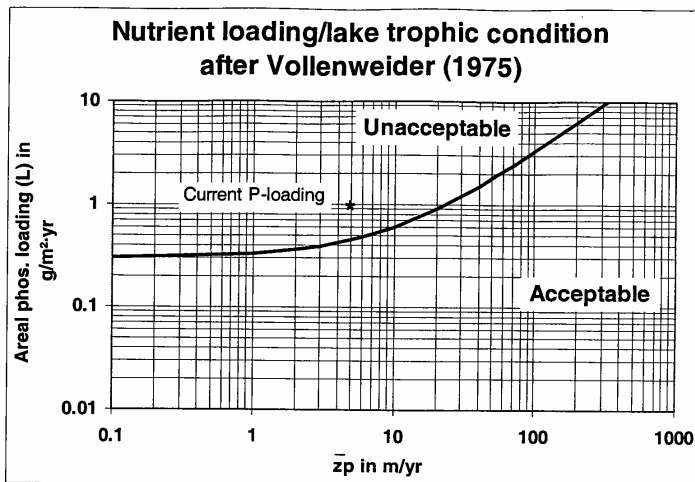
The significance of this areal loading rate is better illustrated in Figure 22 in which areal phosphorus loading is plotted against the product of mean depth and flushing rate. Overlain on this graph is a curve, based on Vollenweider's model, which represent an acceptable loading rate that yields a phosphorus concentration in lake water of 30 µg/L (0.03 mg/L). A phosphorus concentration of 0.03 mg/L is one that is near the median phosphorus concentration for mesotrophic lakes according to Vollenweider (Table 6). Lake Greenwood's current loading rate of 0.951 g/m²-yr falls just into the excessive loading portion of the graph.

Figure 22. Evaluation of phosphorus loading and trophic state in Lake Greenwood.

This figure can also be used to evaluate management needs. For example, areal phosphorus loading would have to be reduced to 0.44 $\text{g/m}^2\text{-yr}$ to yield a mean-lake water concentration of 30 $\mu\text{g/L}$. This represents a reduction in phosphorus mass loading to the lake of 1,445 kg/yr , a 54% reduction in the current total annual phosphorus loading.

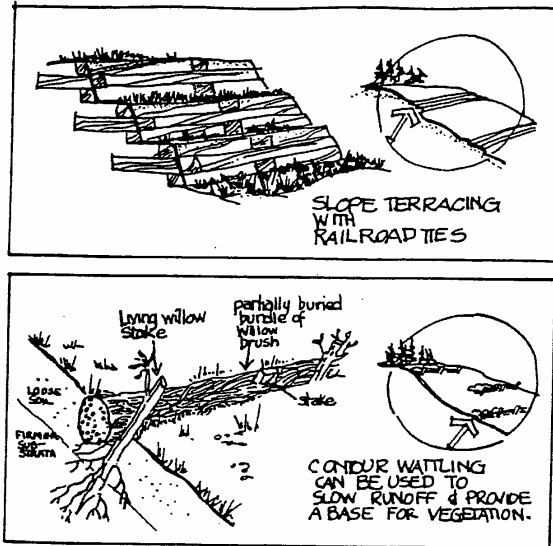
On long, steep slopes leading down to the water's edge where regrading to a gentler slope is too impractical, consider slope modifications which will allow vegetation to become established (Figure 24). Slope terracing provides horizontal steps in which to plant vegetation. Contour wattles are bundles of live willow cuttings anchored into the bluff face with either construction or live willow cuttings (Michigan Sea Grant Program 1988). The bundles trap surface runoff and soil particles and lets vegetation become established.

Figure 24. Modifications for long slopes. Source: Michigan Sea Grant Program (1988)

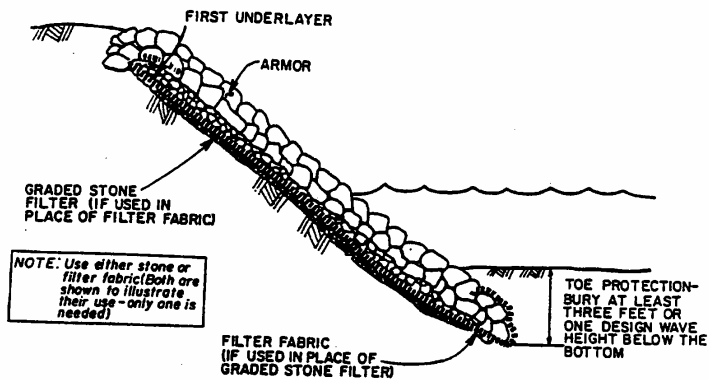
Structural Methods. Riprap is a flexible structure constructed of stone and gravel which is designed to protect steeper (slope > 1:1) shorelines from wave action, ice action and slumping due to seepage. The riprap is flexible in that it will give slightly under certain conditions. This improves its ability to dissipate wave energy. Riprapping involves more than simply dumping rocks on the shoreline. Filter fabric or graded stone must be used on the soil base to prevent soil from moving through the stone and undercutting it. The toe (bottom) of the riprap must be protected by burying it at least three feet below the sediment surface (Figure 25). The size of the largest stones used depends on the design wave height. Traditional riprap may be modified to present a more natural look by integrating live cuttings or tamping live stakes of species such as black willows in between the rock layers (Figure 26). The roots improve drainage and create a mat that binds and reinforces the soil, preventing washouts and loss of fines between and below the rocks (Reichert 1995). See SCS Standards and Specifications 580 entitled, "Streambank and Shoreline Protection" (SCS 1989) or your county SCS agent for more information.

Figure 25. Cross section of a properly riprapped shore line. Source: McComas (1986)

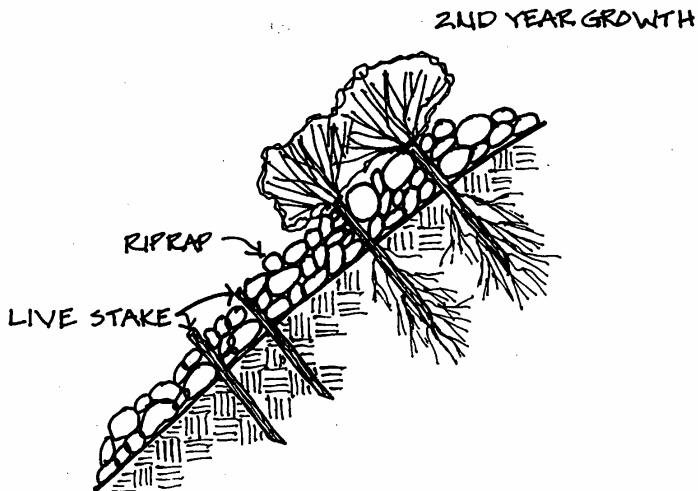
Figure 26. Vegetated riprap. Source: Reichert (1995).

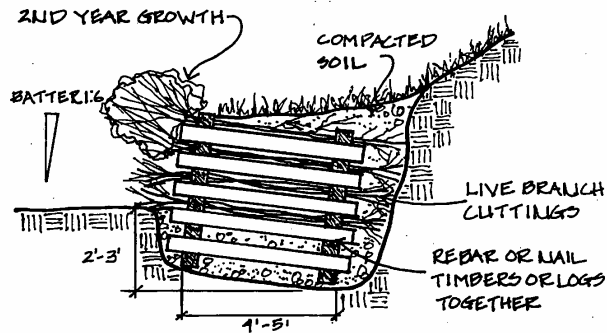
Other bioengineering components that integrate vegetative and structural components include live cribwalls (Figure 27) and vegetated gabions (Figure 28). In a live cribwall, a log or timber crib is combined with live branches of willows, alders, dogwood or other deeply rooted woody species. Plant stakes can be cut during dormant periods (spring, winter or fall) from available stands on site but must be used the same day as cut. Live cribwalls are effective at the base of slopes where a low wall, not higher than 6 feet, is required (Reichert 1995).

Figure 27. Live cribwall. Source: Reichert (1995).

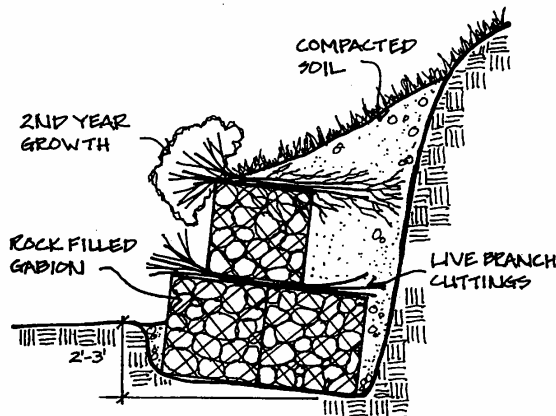
Vegetated gabions combine the same woody species as above with gabions (wire mesh rectangular boxes filled with stone and used as a retaining wall). The gabions may be stacked or terraced.

Figure 28. Vegetated gabion. Source: Reichert (1995).

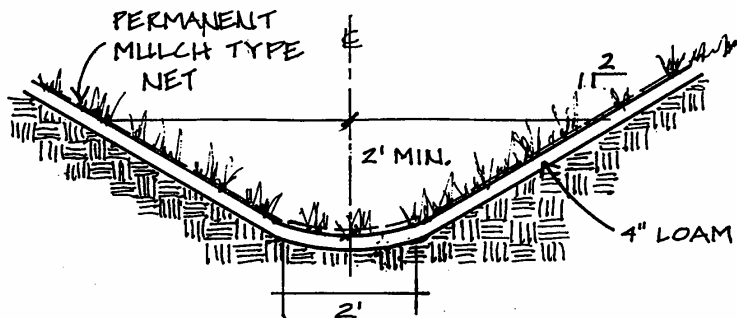
Grassed waterways (grass lined ditches) are natural or constructed waterways or outlets, shaped or graded, and established in suitable vegetation. They provide an opportunity for sediments and other pollutants to be removed from runoff water before it enters surface waters by controlling, slowing and filtering the water through vegetation or structures (Reichert 1995). They are probably the least expensive but most effective means of conveying water across gently-sloping (0 – 5% slope) land. The ditch banks should have a maximum slope 2 horizontal : 1 vertical ratio. The ditch bottom should be flat (parabolic-shaped preferred) and at least 2 feet wide to help slow and disperse water (Figure 29). Generally, the efficiency of pollutant removal by grassed waterways is about 30% but sediment removal efficiencies of 60-80 percent have been reported in properly designed and maintained waterways. Removal efficiencies are maximized by low channel slopes and slow water velocities. Table 24 gives basic design criteria for grassed waterways.

Figure 29. Grass-lined ditch detail. Source: Reichert (1995).

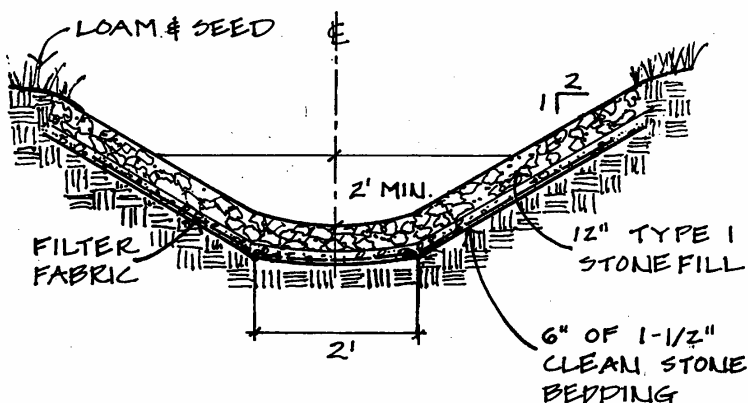
Stone-lined ditches are another alternative to paved ditches where channel slopes are too steep for grass-lined ditches. For channel slopes of 5 – 10%, a 7.5-inch lining of 2-6 inch diameter rock is recommended (Figure 30). For slopes steeper than 10%, a 12-inch lining of 3-12 inch diameter rock is needed (Reichert 1995).

Figure 30. Stone-lined ditch detail. Source: Reichert (1995).

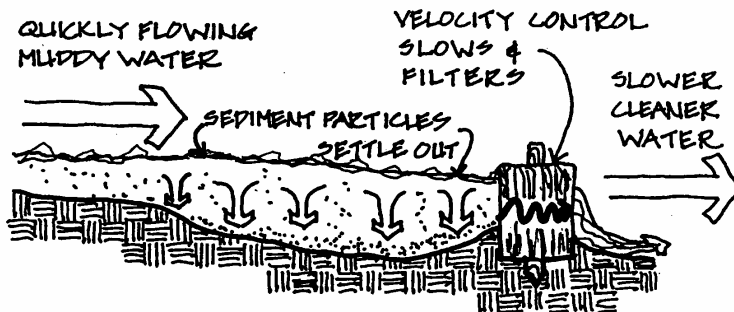
In long drainageways, drop structures should be used to slow down water velocity. Drop structures are low-head structures placed across a drainageway (Figure 31). Reducing water velocity not only decreases the erosive potential of the flowing water, but also allows sediment particles (and attached nutrients) to settle out. In addition, woody debris and trash may also be trapped before reaching culverts and becoming lodged inside. The velocity control may be sheet piling, wood timbers, or rock. In addition, they temporarily store a small amount of water that reduces the peak runoff volume. These have been effectively used in other LARE projects (for example, Lawrence Pontius Ditch – Figure 32).

Figure 31. Typical velocity control structure. Source: Reichert (1995).

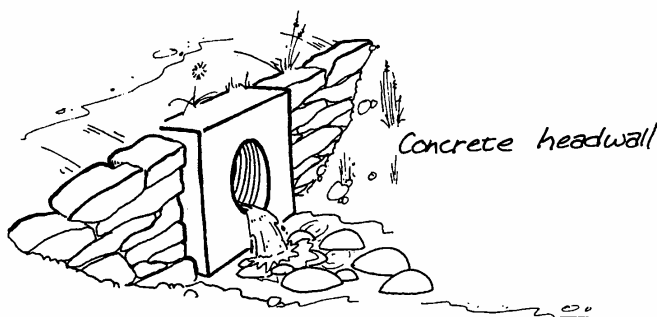
Culverts. Existing erosion damage around and below affected culverts should be repaired to prevent additional damage. In time, erosion at a culvert outlet will work its way upgradient to destabilize the entire culvert. To prevent this, eroded culvert outlets must be protected with rock or concrete reinforcement. Many of the culverts surrounding Lake Greenwood were protected with concrete headers and sills (Figure 32). Headwalls help prevent the undercutting and back cutting problems. Unprotected culverts (see Figure 13) require the stabilization afforded by headwalls. In addition, drainageways below culverts can be protected with stone lining as discussed above to prevent downstream erosion. A plunge pool or basin immediately below culvert outlets will help trap additional sediments. The total cost of materials, labor and equipment to replace a culvert, install a concrete header, and stabilize the banks with riprap can cost as much as \$10,000 but can save \$25,000 in maintenance over 35 years (Vermont Local Roads 1997).

Figure 32. Culvert outlet protected with a concrete header. Source: Lambert (1997).
